EVALUATION OF THE PROXIMAL ARTICULAR SET ANGLE

Jeffrey Boberg, DPM

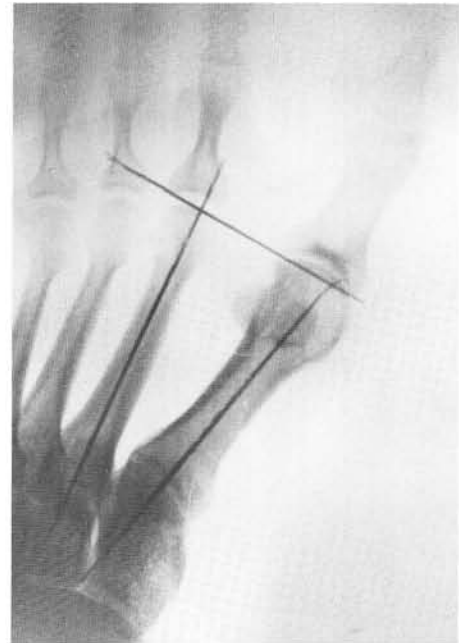
Figure 4. Joint congruity has been restored intraoperatively and an x-ray is taken. No real joint deviation is observed.

This anatomic relationship can now be applied to clinical and radiographic evaluation of the PASA. Preoperatively, the hallux can be adducted on the metatarsal head until end range of motion is met (the base of the phalanx sits in the medial sagittal groove). The position of the hallux in relation to the first ray can now be visualized. An x-ray taken in this position will confirm joint congruity and measurements of the articular surface can be accurately obtained. (Figures 3, 4) In a small percentage of cases, this procedure can be performed secondary to soft tissue contracture.

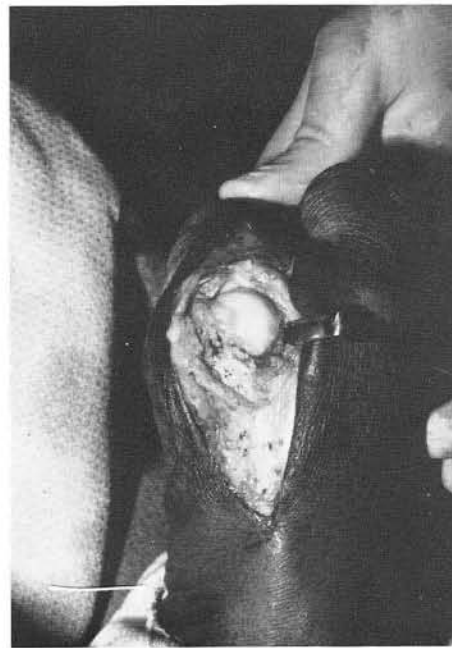
Figure 5B. Intra-operative evaluation of the joint surface shows an apparent lateral deviation.

Ultimately, final judgement is made by direct visualization of the joint surfaces intraoperatively. After the joint is opened and a lateral release performed, the base of the proximal phalanx is placed in the sagittal groove and the articular position is observed. This will give an anatomically accurate representation of the articular surface. (Figures 5A-C)

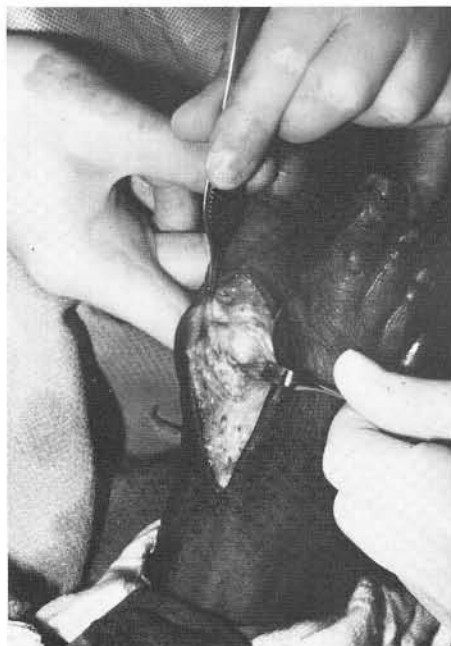
Figure 5C. With the joint held in anatomic congruity, no lateral deviation is noted.
