INTRA-ARTICULAR FRACTURE FOLLOWING AUSTIN OSTEOTOMY

Raymond G. Cavaliere, DPM

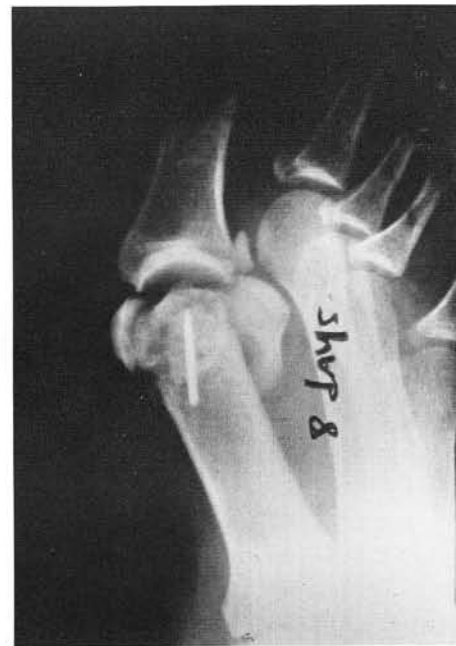
Figure 1. Postoperative view (8 days) following an Austin bunionectomy. Note the shortening of the first ray segment, loss of joint congruity, and intra-articular fracture of the metatarsal head with dorsal displacement of the superior fragment.

In the asymptomatic patient, a radiographic sign signifying intra-articular fracture is early shortening of the first metatarsal. This sign would signify collapse of the first metatarsal head. (Figure 1) In addition, loss of first metatarsophalangeal joint (MPJ) symmetry would be observed with dislocation of the capital fragment. Dorsal dislocation of the superior metatarsal head fragment is seen, especially where the plantar wing is rigidly stabilized with a fixation device.

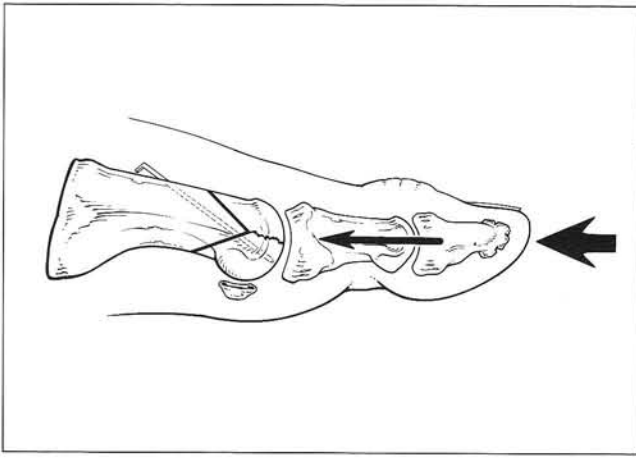
Figure 2. Direct trauma creating impaction of the joint may lead to an intra-articular fracture of the metatarsal head.

One possible reason for an intra-articular fracture is direct trauma to the first MPJ resulting in impaction of the proximal metatarsal segment into the capital fragment of the metatarsal head. This trauma could occur if the patient stubbed their great toe in the immediate postoperative phase. (Figure 2)

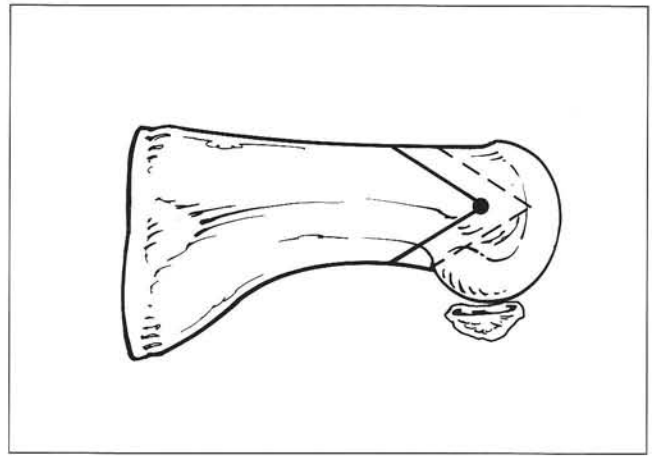
Figure 3. Normal location of the Austin osteotomy compared to an osteotomy placed too close to the articular surface of the metatarsal head, increasing the likelihood for fracture of the capital fragment.

In the absence of associated trauma, poor or inaccurate surgical technique may be a primary factor. This situation may include an apex which is placed too distally (Figure 3) with not enough substantial bone substance to prevent fracture of the capital fragment at the apex, followed by separation of the dorsal and plantar wings of the capital fragment. Excursion of the saw blade past the apex while performing the osteotomy may lead to an intra-articular fracture as well. (Figure 4)

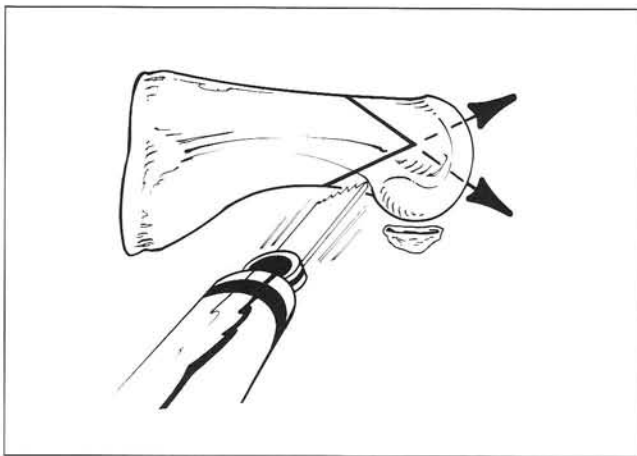
Figure 4. Saw cuts extending beyond the apex point may create direct violation of the articular surface, or create stress risers that lead to intra-articular fracture of the metatarsal head. The use of an apical axis guide wire may reduce the incidence of intraoperative complication.

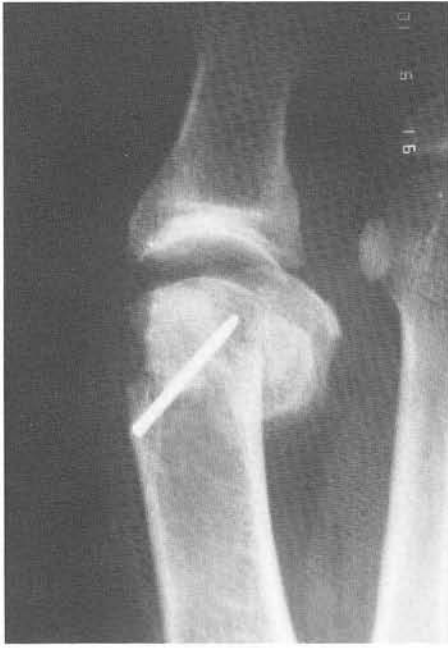
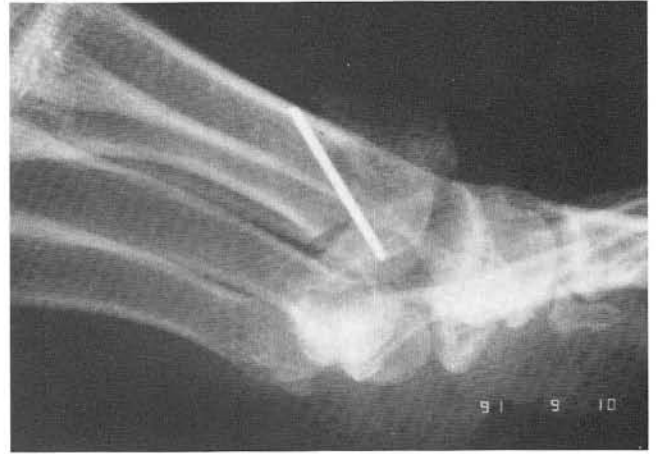
Figure 5B.

Figure 5A, 5B. Postoperative intra-articular fracture following Austin osteotomy with internal pin fixation. Note the dorsallateral dislocation of the superior fragment.

In most instances, intra-articular fracture and displacement of the capital fragments of an Austin-type osteotomy will require an additional surgical intervention for reduction and secure fixation. (Figure 5A, 5B) Surgical repair should re-establish the congruity of the articular surface of the metatarsal head, length of the metatarsal and ultimately weight-bearing function of the first ray segment.

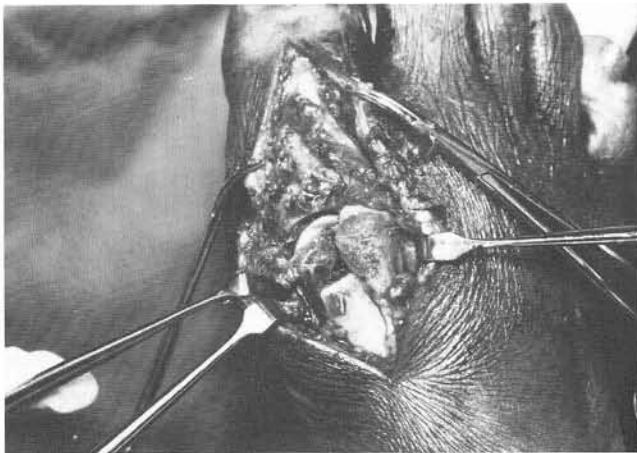
Figure 6A. Intra-operative identification of the capital fragments.

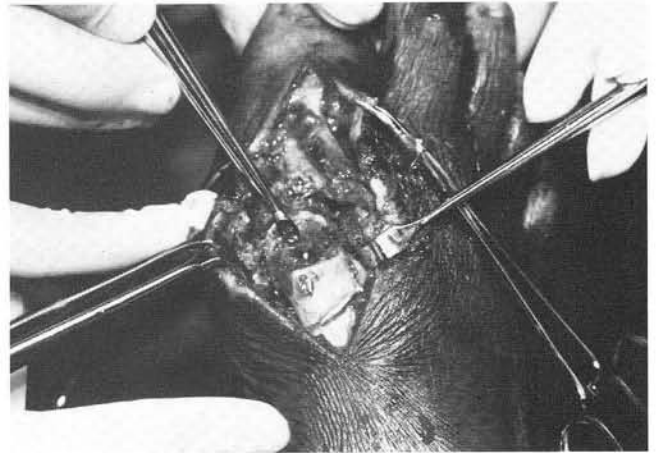
Figure 6B. Intra-operative curettage of the capital fragments.

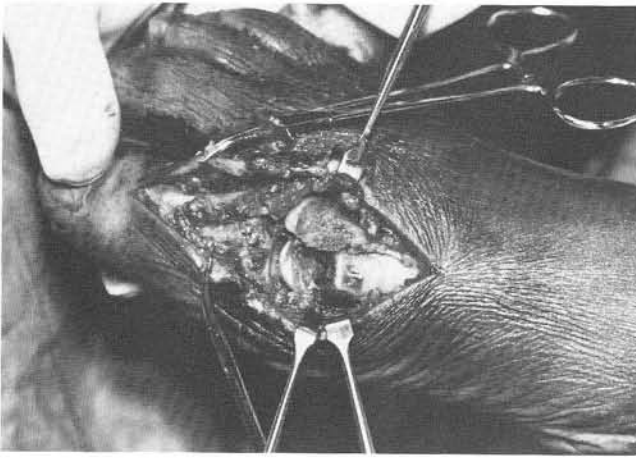
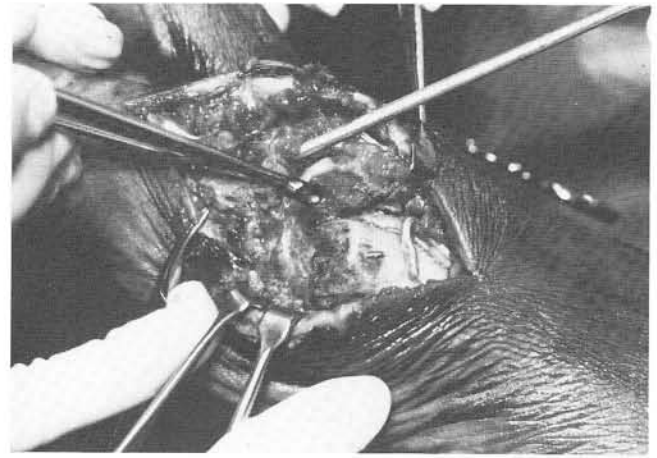
Figure 7B.

Figure 7A, 7B. Intra-operative view of the metatarsal head fragments and inspection of the bone loss.

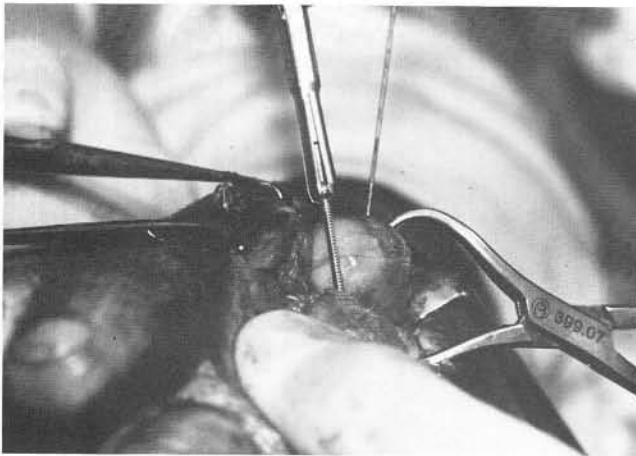
Figure 8A. Anatomic reduction and restoration of the articular surface of the metatarsal head. Reduction of the alignment of the capital fragments is maintained by the insertion of two 2.0 mm cortical screws.

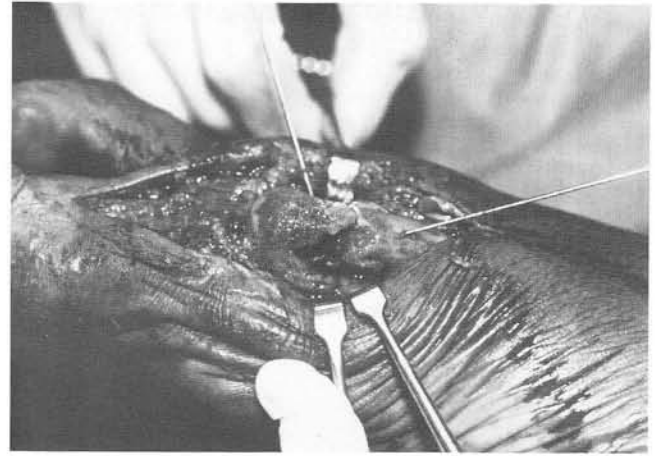
Figure 8B. Temporary anatomic reduction. Note the loss of bone substance between the metatarsal head and the plantar cortex of the proximal metatarsal segment.

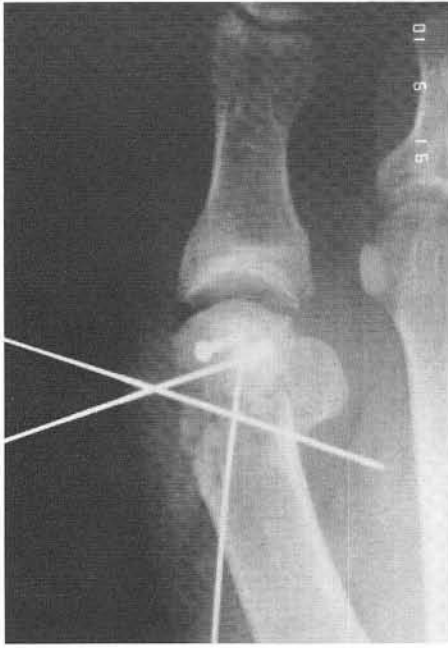
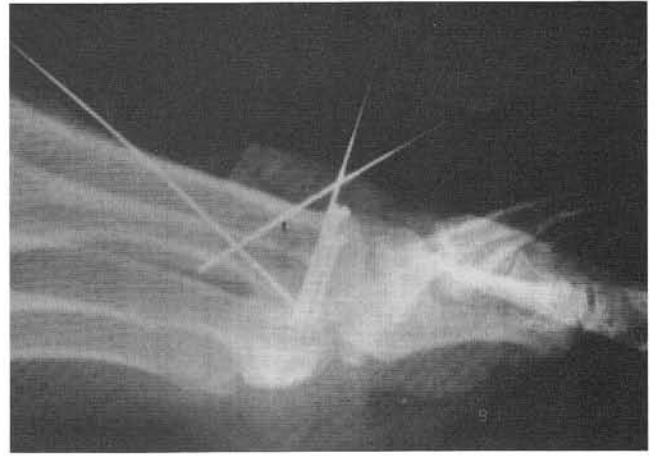
Figure 9B.

Figure 9A, 9B. Intra-operative x-ray demonstrates anatomic restoration of the metatarsophalangeal joint and length of the metatarsal segment. The defect had been repaired with the use of a bone graft

wound dehiscence and positive wound cultures of *Pseudomonas aeruginosa*. Bone cultures were negative even though loss of bone substance was noted intra-operatively. Bone grafting was necessary for the final repair and the overall site was secured by plate fixation. Intravenous antibiotic therapy was also employed post-operatively.

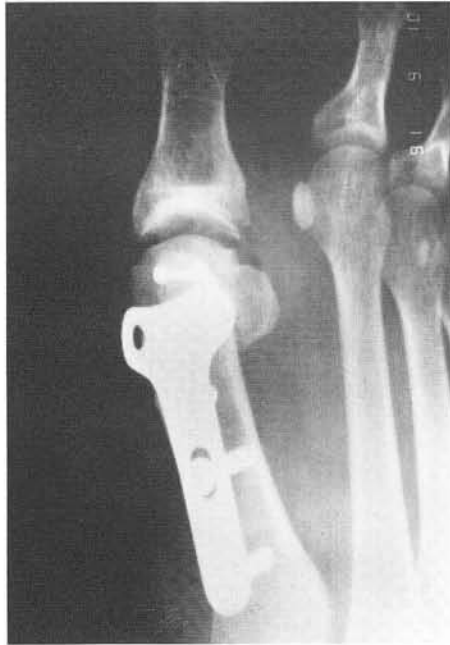
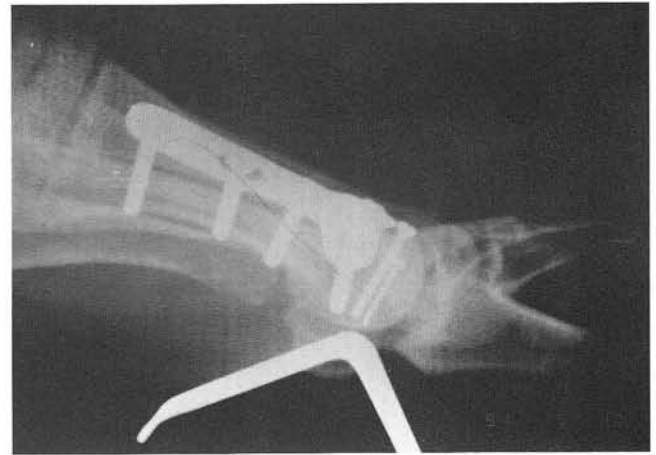
Figure 10B.

Figure 10A, 10B. Intra-operative x-rays demonstrating additional plate fixation for reinforcement of the primary reduction.

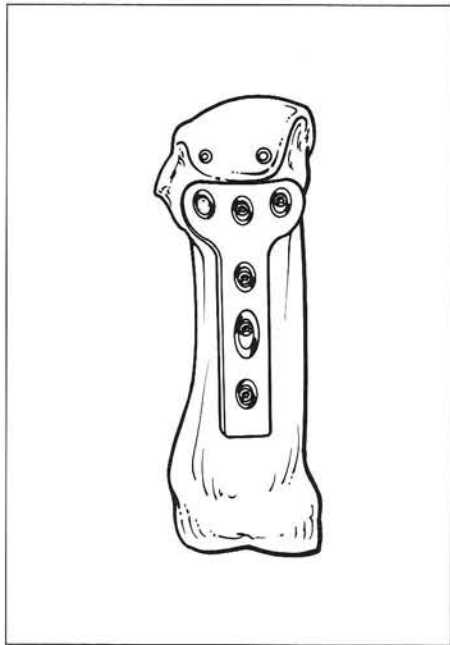
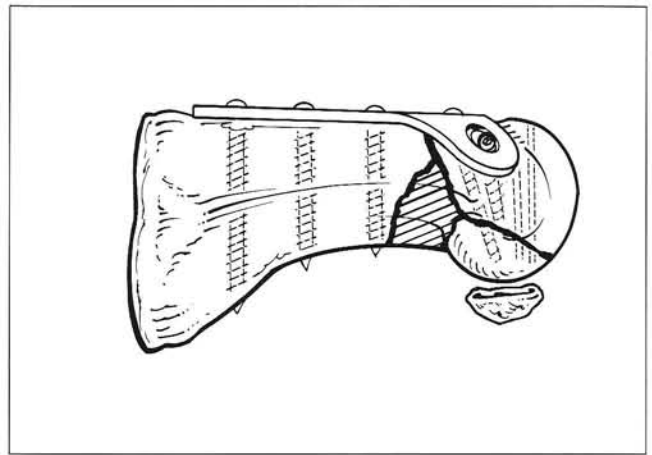
Figure 11B.

Figure 11A, 11B. Reduction and stabilization using a small T-plate.

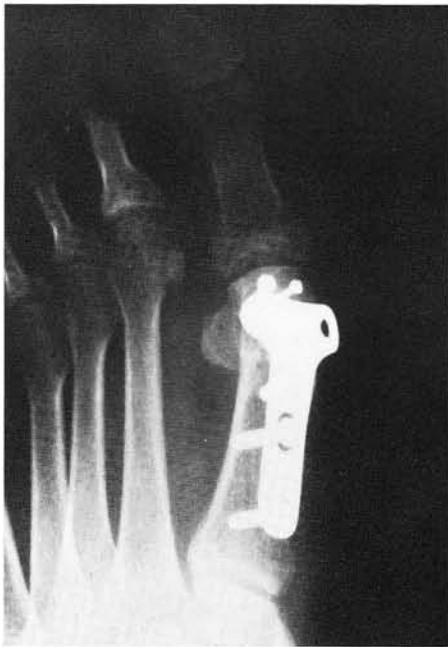
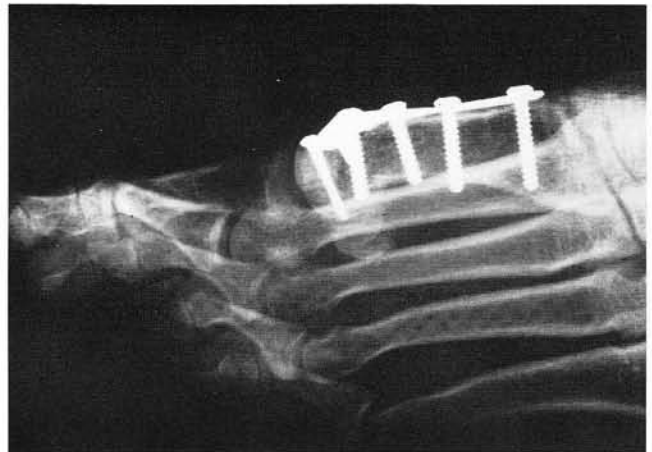
Figure 12B.

Figure 12A, 12B. Final healing and union.
