BIOPRO BREAK-OUT™ CANNULATED SCREW EXTRACTOR

Todd Gunzy, DPM

Todd Haddon, DPM

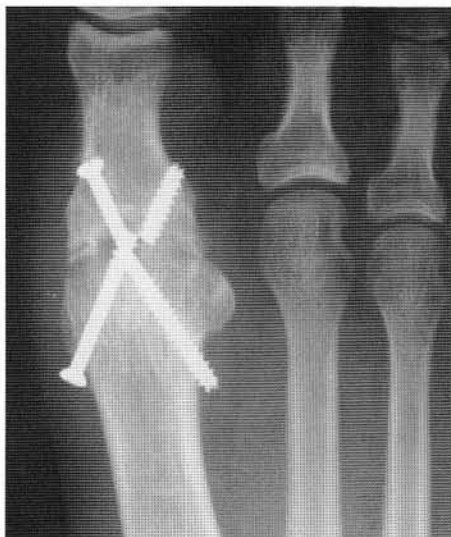
Figure 3. Failed 1st MTPJ arthrodesis demonstrating fractured cannulated screws.

A 56-year-old female presented as a direct referral from a local orthopedic surgeon for a third opinion. The patient was experiencing pain after having had a first MTPJ arthrodesis performed for a symptomatic hallux rigidus 6 months prior. Physical exam revealed a well-healed dorsal incision and faintly noticable motion in the direction of dorsiflexion and plantarflexion at non-union site. The patient experienced pain throughout the examination and during ambulation. Radiographic exam revealed 2 broken 3.0 mm cannulated screws traversing the first MTPJ fusion site. The fatigue fracture of both screws appears to be directly at joint level. An apparent non-union was also noted to this joint with no evidence for consolidation (Figures 3, 4).

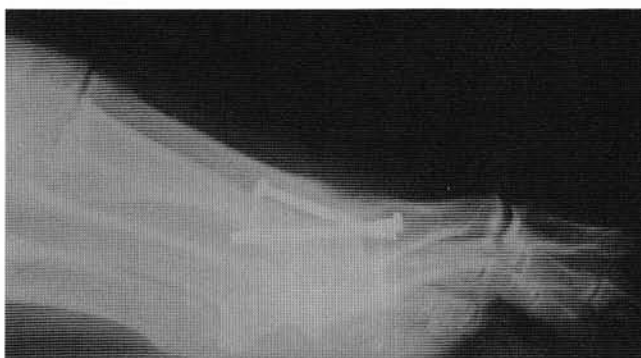
Figure 4. Radiograph of failed 1st MTPJ arthrodesis demonstrating fractured cannulated screws.

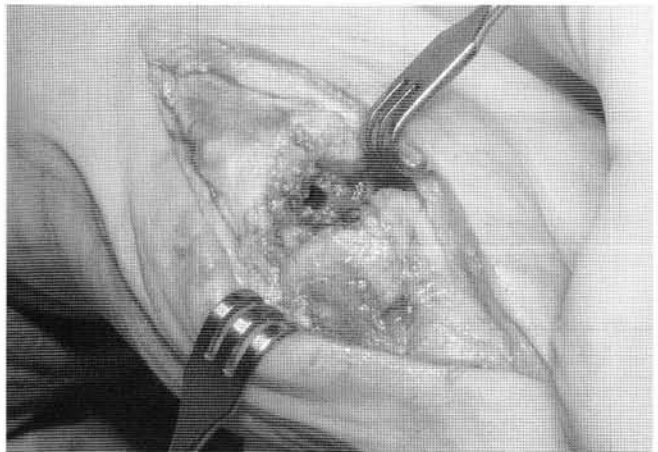
Figure 8. Appearance of the non-union site demonstrating minimal bone loss following screw extraction.
