Removing Stripped Titanium Screws From Locking Plate: Technique and Case Report

Carl Kibm, DPM

William Boegel, DPM

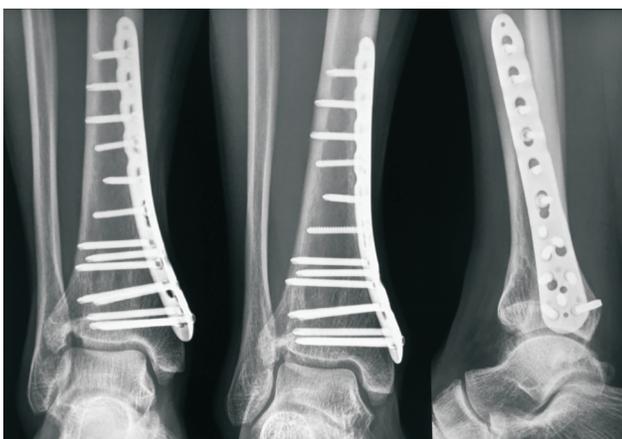
Figure 1. Ankle radiographs demonstrate a long medial tibial pilon plate and 12 screws.

His preoperative clinical examination revealed pain on palpation over the medial malleolus where the plate was palpable. Preoperative radiographs revealed a long medial tibia pilon plate and 12 intact screws (Figure 1). An operative report was not available due to the circumstances. We could not determine, with certainty, the exact diameter and head pattern of the screws. Radiographically, the plate appeared to sit off the bone distally. We anticipated that some of the screws were locked into the plate. We were equipped with an assortment of various sized and shape screwdrivers but we did not have a universal screw removal set. We planned to make an incision over the medial malleolus initially to confirm that we had an appropriate driver and could remove these screws before we made an incision the length of his previous scar for access to the entire plate (Figure 2).

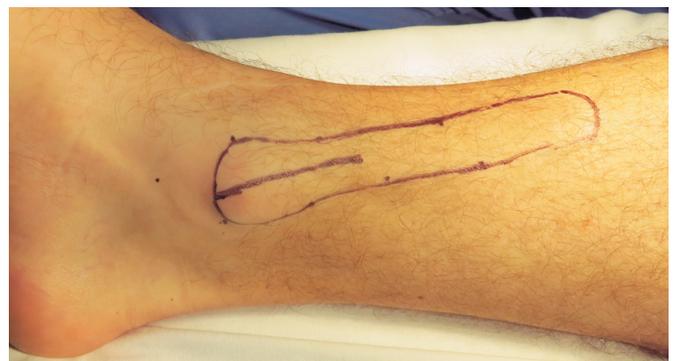
Figure 2. The outline of the prominent plate was traced. We started with a small incision over the distal medial malleolus. We confirmed we were able to remove the screws before expanding the incision the length of the plate.

the medial malleolus and the plate and screws were exposed without difficulty. A 2.7 mm hex screwdriver was used to remove the first screw with ease. Next, we lengthened the skin incision so we could remove the rest of the fixation. We found that 4 of the screws were easy to remove but 8 of the screws appeared to have been power-driven into the plate and their heads were completely stripped. We interposed a piece of Esmarch bandage between the screws and the driver to increase the stability of the driver connection but this did not help. We did not have access to conical extraction screws or carbide burrs. We considered accepting this failed attempt and knew we could come back later with additional equipment if the patient continued to be symptomatic.

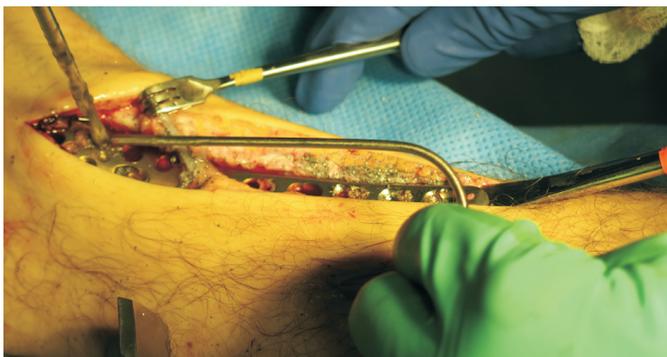
Figure 3. Most (8 of 12) of the titanium screwheads were stripped and the correct driver could not engage the screws; therefore 4.0 mm stainless steel drills were used to drill and destroy the screw heads' interface with the plate. An osteotome was then used to pry the plate off the bone.

To help dissipate the heat generated from this process, we maintained cool saline irrigation to our drill bit. Our suction tip was intimate to the drill bit to remove metal debris from the soft tissues (Figure 3). A significant amount of force was required on the drill during this process and equal counterpressure was necessary. We started with firm pressure, oriented perpendicular to the screw head, centrally. We then worked on a different screw to allow time for cooling. We used the drill on various obliquities to weaken the remaining screw heads. It was not obvious

when each screw-plate attachment had been weakened sufficiently. Once all the heads were drilled, we used a small, straight osteotome to get under the plate and we gently tapped an osteotome with a mallet to further weaken the screws to failure. This also helped us to identify where the osteotome could not pass and therefore we learned where more drilling was needed.

We then inserted the osteotome under the plate, oriented from proximal to distal, so we could pry the plate off the bone. The patient's bone was strong but we were cautious to not refracture his tibia. The remainder of the screws were maintained within the tibia and were not prominent through the soft tissues (Figure 4). Saline irrigation was used to further remove metal debris and a layered closure was performed. Following surgery, the patient was immediately partial weightbearing and had an uncomplicated recovery (Figure 5).

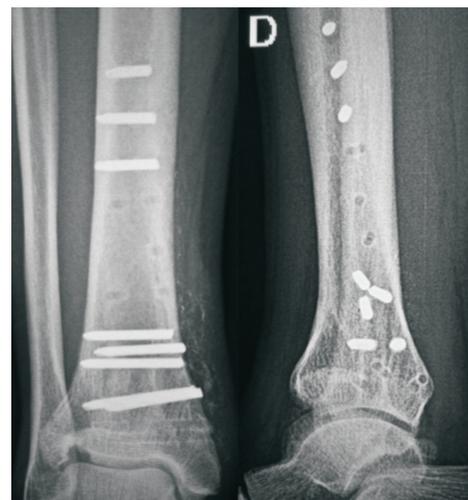
Figure 4. Postoperative radiograph. The prominent plate and screw heads have been removed. Metal debris in the soft tissues is minimal and the screw threads remain within the tibia.

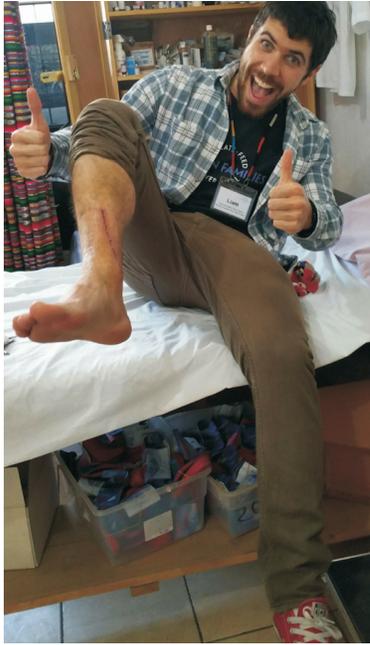
Figure 5. The patient healed uneventfully. He is without pain and is pleased with the results
