ULTRASOUND EVALUATION OF THE PLANTAR FASCIA

James H. Morgan, Jr., DPM, FACFAS, FAAPSM

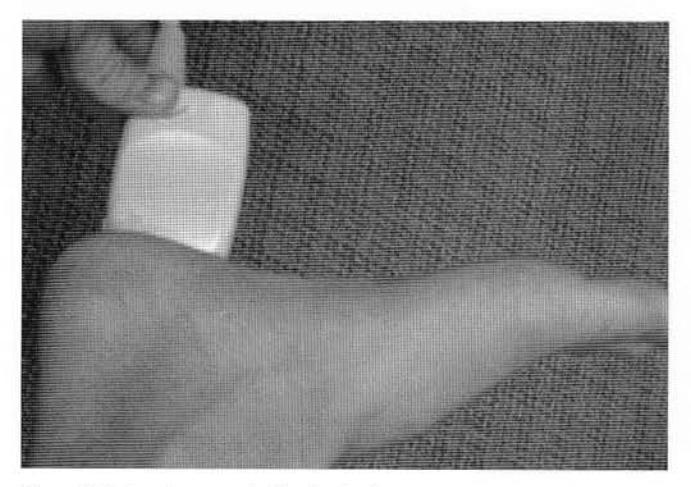
Figure 1. Probe placement for longitudinal scan.

The plantar fascia and associated tissues are best visualized with a 7.5 millihertz (or higher) linear probe. The examination can be performed with the patient in the supine or prone position with the foot dorsiflexed. The plantar fascia should be imaged from the calcaneus into the midfoot especially the medial band. The fascia should be imaged in the longitudinal scan, parallel to the long axis, and transverse scan, perpendicular to the long axis (Figures 1, 2). In heavier patients with thicker fat pads, the probe can be rocked posteriorly and anteriorly to differentiate the inferior margin of the fascia from the plantar fat pad.

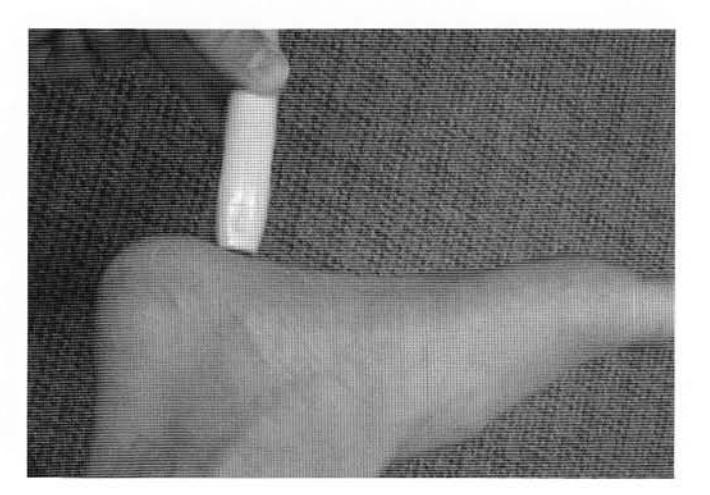
Figure 2. Probe placement for transverse scan.

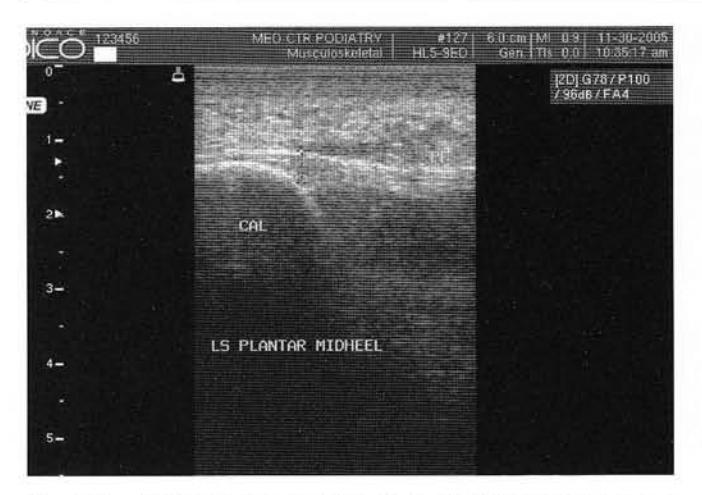
Figure 3. Longitudinal scan of normal plantar fascia. The plantar surface of the foot is located at the top of the screen. The posterior surface is to the left of the screen. The calcaneus is the hyperechoic convex area labeled CAL. The plantar fascia is the linear parallel hyperechoic structure running from left to right from the calcaneus.

Normal fascia will appear as a thin hyperechoic or brighter structure with multiple parallel lines on the longitudinal scan (Figure 3). The normal fascia typically

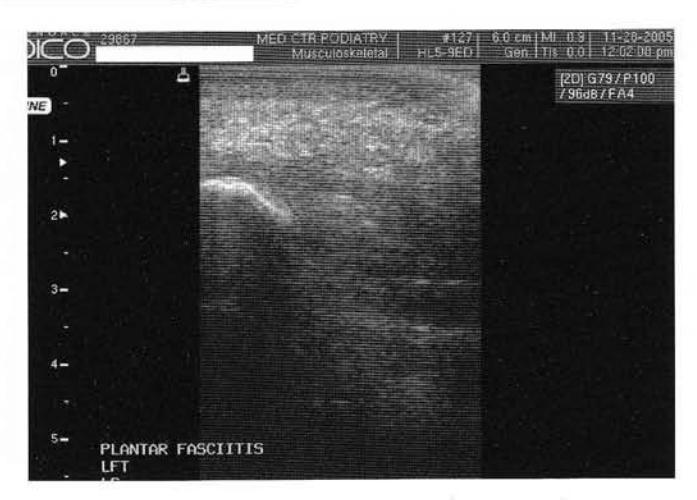
Figure 4. Longitudinal scan of abnormal plantar fascia. Note the increase in hypoechoic appearance of the fascia. The fascia thickness is 0.73 centimeters.

measures less than 4 mm in thickness. Abnormal fascia will have an increased thickness (>4 mm) and decreased echogenicity sometimes with focal hypoechoic or darker areas representing cystic degeneration (Figure 4). Contralateral comparison scans should be performed to compare measurements of thickness. Plantar fascia tears are seen as a disruption of the normal fibrillar architecture with focal fluid filled hypoechoic areas (Figure 5). These tears can be intrasubstance or end-to-end, either partial or full-thickness. Calcaneal spurs are seen as hyperechoic flecks extending from the calcaneus in the insertional region (Figure 6). Remodeling to the calcaneal tuberosity can also be seen, and this may be suggestive of arthropathies. Infracalcaneal bursitis will appear as comma-shaped heterogeneously hypoechoic masses located directly inferior to the calcaneal tuberosity (Figure 7). Plantar fibromas appear as round to oval shaped well-defined to moderately infiltrative heterogeneously hypoechoic masses located adjacent to the inferior margin of the plantar fascia (Figure 8, 9).

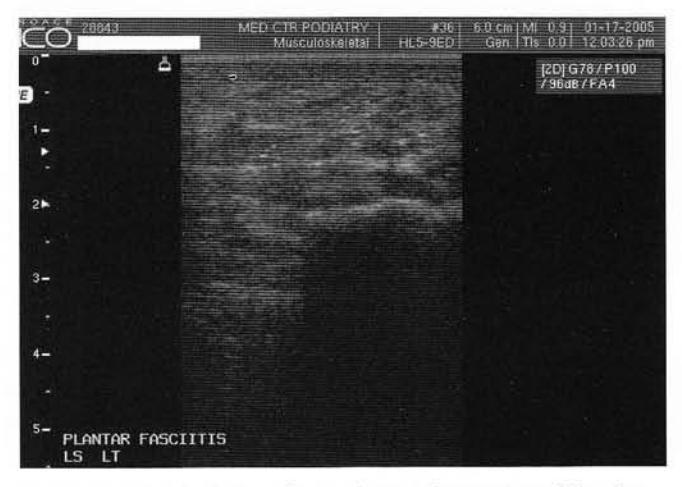
Figure 5. Longitudinal scan of intrasubstance degeneration of the plantar fascia. Note the fusiform thickening with focal hypoechoic region located at the insertional portion at the anterior aspect of the calcaneal tuberosity.

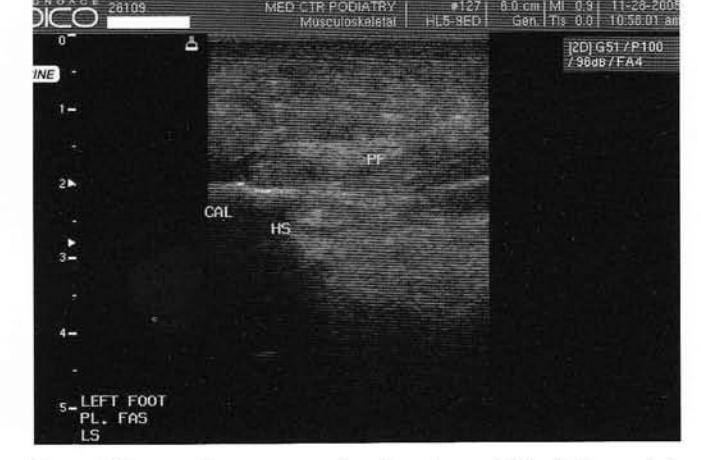
Figure 6. Sonographic appearance of a calcaneal spur (HS), the hyperechoic extension of the calcaneal tubercle. Notice the hypoechoic changes of the plantar fascia (PF).

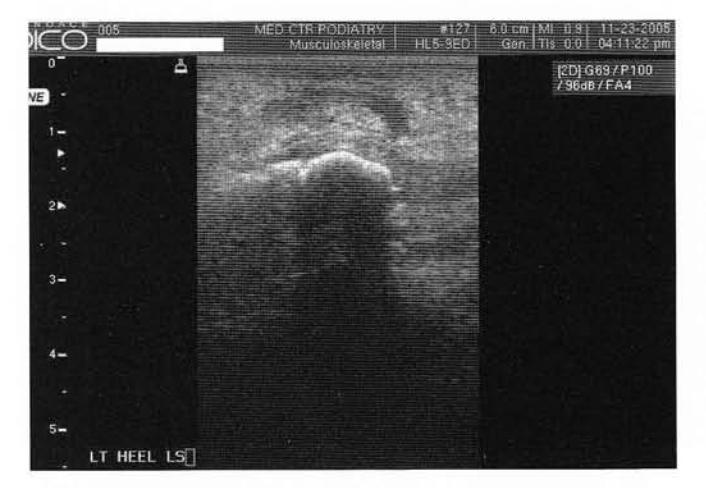
Figure 7. Sonographic appearance of infracalcaneal bursitis. Notice the heterogeneous mixed echoic mass located inferior to the calcaneal tubercle.

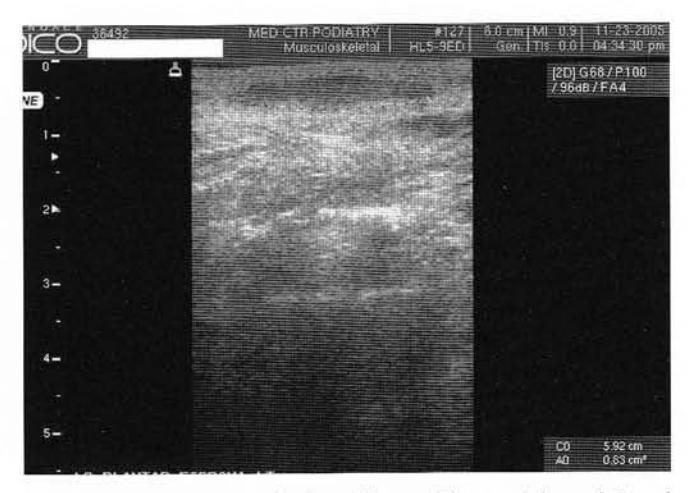
Figure 8. Longitudinal scan of a plantar fibroma. The mass is hypoechoic and located along the inferior surface of the fascia.

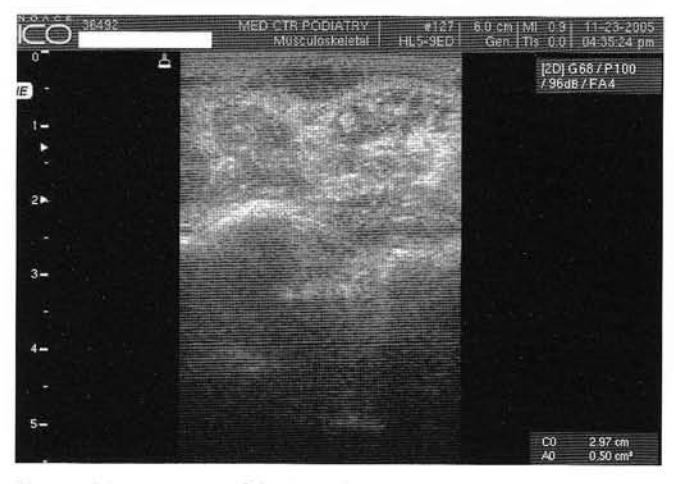
Figure 9. Transverse scan of the same plantar fibroma.

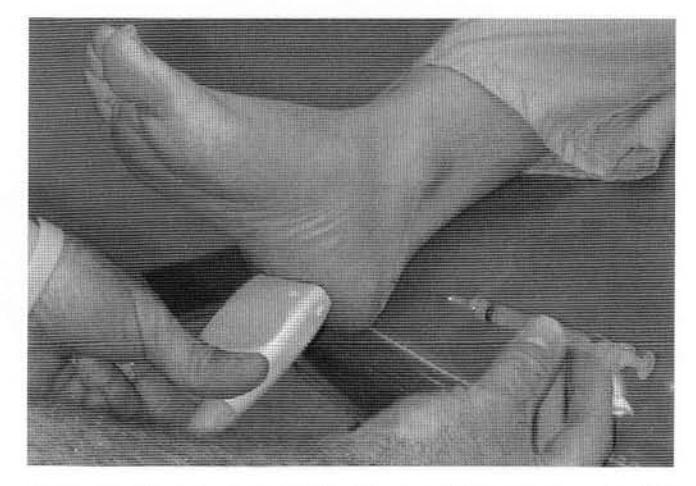
Figure 10. Ultrasound-guided injection of the plantar fascia – medial/ transverse approach.

Ultrasound guided injections of the plantar fascia and infracalcaneal bursa have been used with excellent results by the author. A medial to lateral approach with the injection, perpendicular to the long axis of the fascia, is the author's preferred method (Figure 10). The injection site is prepped using alcohol or betadine. The probe is placed in the transverse scan position parallel

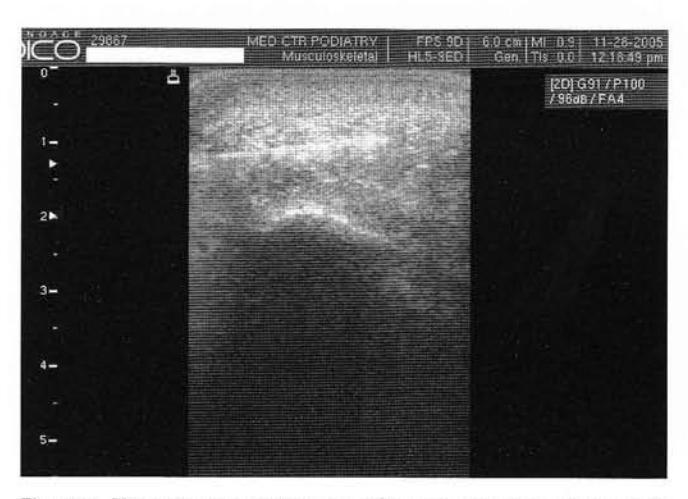
Figure 11. Transverse scan pre-injection. The needle appears as a hyperechoic linear structure in the plantar heel pad.

to the needle. The needle will appear as a hyperechoic linear structure (Figure 11). The needle should be positioned inferior to the fascia band. Upon injection of the local /cortisone mixture, a hypoechoic bolus will appear (Figure 12). The use of ultrasound guided injections will prevent intrafascial injections, thereby reducing the risk of potential rupture.

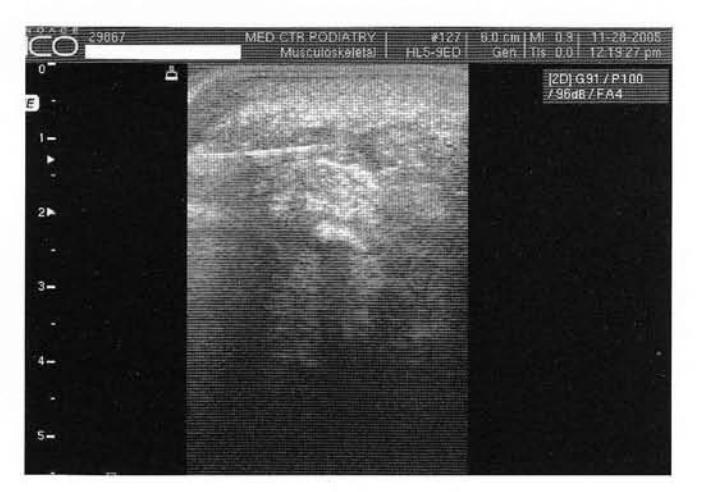
Figure 12. Transverse scan post-injection. Notice the hypoechoic bolus to the right of the hyperechoic needle.
