The “BONE ANCHOR SIGN:” Sign of Failure of Bunion Surgery

John V. Vanore, DPM

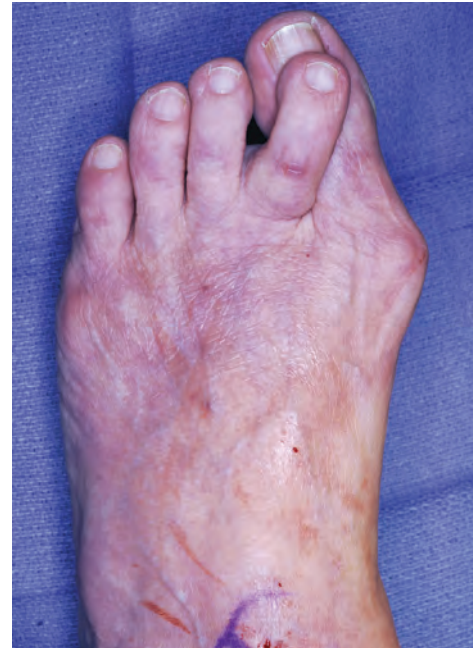
Figure 1A. Preoperative clinical view of Case 1 showing a significant bunion deformity although postoperative prior bunion surgery. The patient felt the deformity progressively worsened postoperatively.

Patient 1 is a 69-year-old woman who presented with a symptomatic bunion deformity with history of prior surgery (Figure 1). Clinically, she exhibited quite a severe bunion deformity with abduction of the great toe. The second toe was medially deviated and overlapping the hallux. Clinically, a dorsal medial bunion prominence was apparent despite her history of previous bunion surgery. Radiographs illustrated resection of the medial eminence with significant abduction of great toe and hallux adductus angle of 50° . The intermetatarsal angle measured 20° . The second toe showed dorsal and medial subluxation of the second MTP joint. Two metallic bone anchors were noted along the medial eminence first metatarsal head. Radiographs did not illustrate any apparent osteotomy performed during the prior bunionectomy. Her hindfoot architecture, clinically and radiographically were essentially normal with good range of motion and no pain or crepitus on motion.

Bone anchors are a well-accepted and commonly practiced method for reattachment of soft tissue to a particular area of bone. The utilization of a bone anchor as an adjunctive device for hallux valgus repair will be reviewed. Case 1 involves placement of 2 bone anchors as an adjunct to the medial capsular repair of a bunionectomy. The surgeon chooses not to perform an osteotomy despite an apparent significant deformity. There is obvious failure to obtain any sort of correction of the bunion deformity. Obviously, the bone anchor is not necessarily the reason for failure but perhaps the surgeon believed that use of the bone anchor might provide some type of soft tissue correction although it was not achieved.

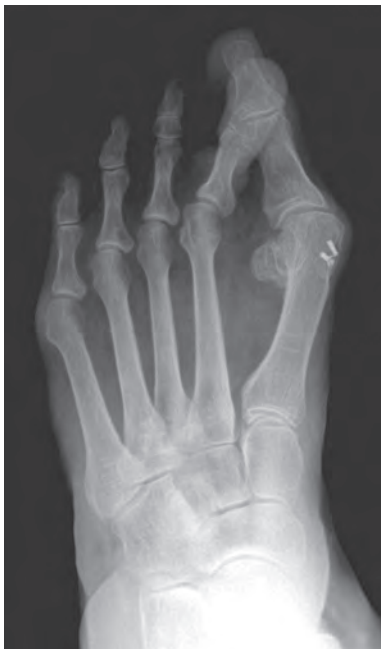
Figure 1B. Preoperative radiograph of Case 1. Note the 2 bone anchors within the medial aspect of the first metatarsal head and significant hallux abductus deformity.

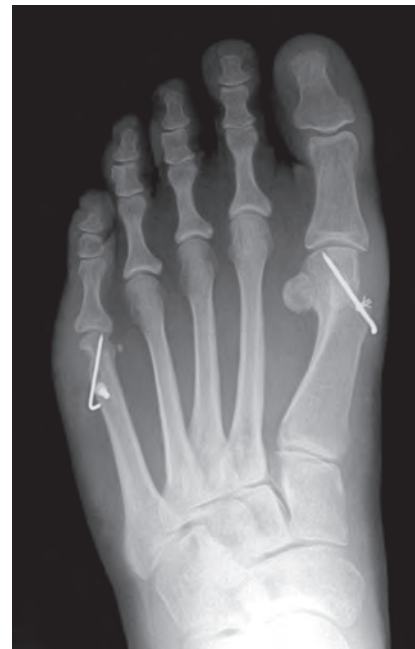
Figure 2. Radiograph of patient in Case 2 illustrating Chevron bunionectomy with use of “anchor enhanced capsulorrhaphy.” The patient reported symptoms associated with prominent hardware. Correction of deformity was adequate.

Patient 2 is a 29-year-old woman who presented with a symptomatic left foot associated with bunion surgery that had been performed 2 years prior (Figure 2). The patient reported discomfort along the medial aspect of the first MTP joint with palpable subcutaneous hardware. Clinically, she showed relatively good correction of the bunion deformity although symptoms were associated with shoe irritation of the hardware and overlying skin. Radiographs showed prior

bunion surgery with distal osteotomy. Good position of the great toe was noted with consolidation of osteotomy. A Chevron-type osteotomy was performed with a bone anchor and Kirschner wire (K-wire) placed along the overhanging ledge of the most medial aspect of the first metatarsal shaft. The K-wire was placed from medial to lateral across the

osteotomy and buried subcutaneously, with the wire buried in an area of likely irritation. Interestingly a similar technical error was observed with a separate procedure involving the fifth metatarsal. She possessed a good range motion of the first MTP joint with no pain or crepitus on range motion and was satisfied with the correction obtained but had difficulty wearing shoes due to medial irritation of the subcutaneous hardware.

Case 2 actually showed adequate correction of the bunion deformity with a combination of osteotomy and soft tissue repair. A bone anchor was utilized presumably to augment the soft tissue repair. The osteotomy was fixated with a K-wire buried along the medial aspect of the overhanging ledge of the capital osteotomy. Subsequent surgery was required to remove both the metallic bone anchor as well as the buried K-wire acknowledging that the latter most likely contributed to her presenting symptoms and need for additional surgery. Generally, the bone anchor may provide a method for placing the capsular tissues under a degree of tension to affect the soft tissue repair.

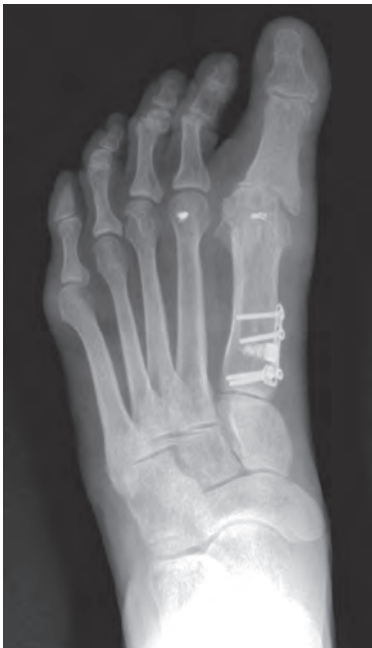
Figure 4A. Anteroposterior radiograph of Case 4 showing a more dorsal and distal placement of the bone anchor presumably utilized during the hallux valgus repair. Note the loss of first MTP joint space and varus deformity.

Patient 4 is a 73-year-old woman who presented with a symptomatic left foot. She presented with tenderness at the level of the first MTP joint and a history of prior surgery, (Figure 4). Clinically, adduction contractures of the hallux, second, and third toes was apparent. The patient showed a diminished range of motion of the first MTP joint, as well as tenderness on range of motion. Radiographically, there was evidence of an opening proximal first metatarsal osteotomy with plate fixation. Adduction of the hallux was apparent with a long great toe. A metallic bone anchor was noted within the distal and dorsal first metatarsal head.

Case 4 demonstrates another example of a proximal first metatarsal osteotomy this time with good reduction of the intermetatarsal angle. The radiographs illustrate

overcorrection resulting in a hallux varus deformity. Narrowing of the joint space is observed with degenerative changes. A bone anchor is observed, placed in a dorsal position in the first metatarsal head. The position of the bone anchor cannot be explained. The procedure is a failure although the failure cannot be attributed to the bone anchor.

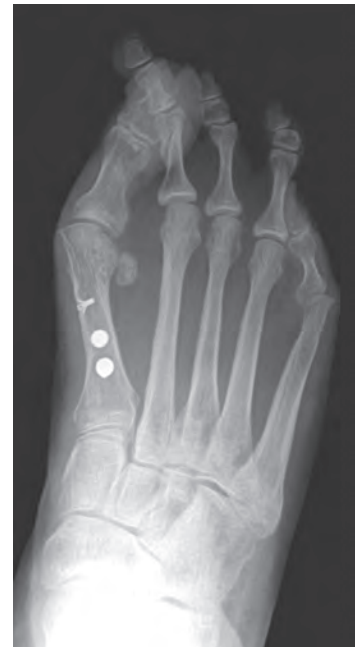
Figure 3. Anteroposterior radiograph of Case 3 showing a recurrent bunion deformity despite the use of “anchor enhanced capsulorrhaphy” combined with proximal first metatarsal osteotomy.

Patient 3 is a 76-year-old woman who presented with reports of a painful right foot associated with recurrent foot deformities. She had a history of prior foot surgery by a university foot surgeon and described that her foot was in worse condition than prior to surgery (Figure 3). Her radiographs show prior bunionectomy with retained metallic fixation, 2 screws within the proximal first metatarsal (associated, I assume with proximal osteotomy although no apparent correction could be perceived) as well as a bone anchor placed within the medial portion of the distal first metatarsal just proximal to the anatomic neck region. Radiographs showed an intermetatarsal angle that measured 16° with a hallux abductus angle of 50° . A degree of adduction of the lesser toes were noted most notably the second and third with an oblique fracture within the distal half of the second toe proximal phalanx. Flexion of the second and third toes was also apparent.

Case 3 involves another case of hallux valgus repair. This patient did undergo a proximal osteotomy but no meaningful reduction of the intermetatarsal angle can be demonstrated. The metatarsal head was “staked” and there is a very high hallux abductus angle. Soft tissue repair of the first MTP joint certainly is inadequate and the procedure as a whole is a complete failure.

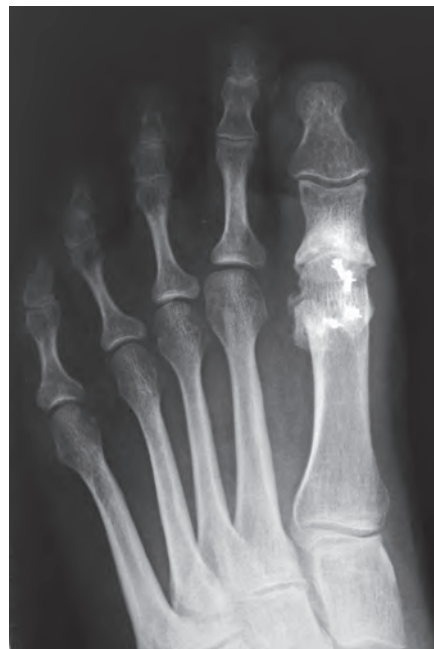
Figure 5A. Anteroposterior radiograph of Case 5, revealing the use of four bone anchors for securing placement of a soft tissue membrane arthroplasty.

Patient 5 is a 54-year-old woman who presented with a symptomatic left foot with a history of multiple prior surgeries. The patient had a prior cheilectomy as well as subsequent membrane arthroplasty performed by a university orthopedic foot and ankle surgeon. She has experienced continued pain and difficulty with daily activities. Radiographs show evidence of prior surgery with the shortened left great toe (Figure 5). There has been resection arthroplasty of the great toe proximal phalangeal base with several metallic bone anchors within the substance of the first metatarsal head. Clinically, she showed limited range motion and tenderness on range of motion although no acute joint inflammation or swelling was present.

Case 5 is an example of utilization of the bone anchor to secure extrinsic tissue as a membrane or interpositional arthroplasty. Four bone anchors were utilized, as well as a synthetic material. The arthroplasty did not provide the patient with relief. The patient continued to have a painful, stiff, and shortened toe with no toe purchase. This procedure also must be classified as a failure because the patient required subsequent surgery. These cases illustrate complications of the surgical procedure and poor to mediocre outcome in each instance of utilization.
